MEADOW GREEN FARM SUMNER COUNTY, TENNESSEE SITE DOCUMENTATION

May 2014

**A Public Service of the
Tennessee Civil War National Heritage Area**

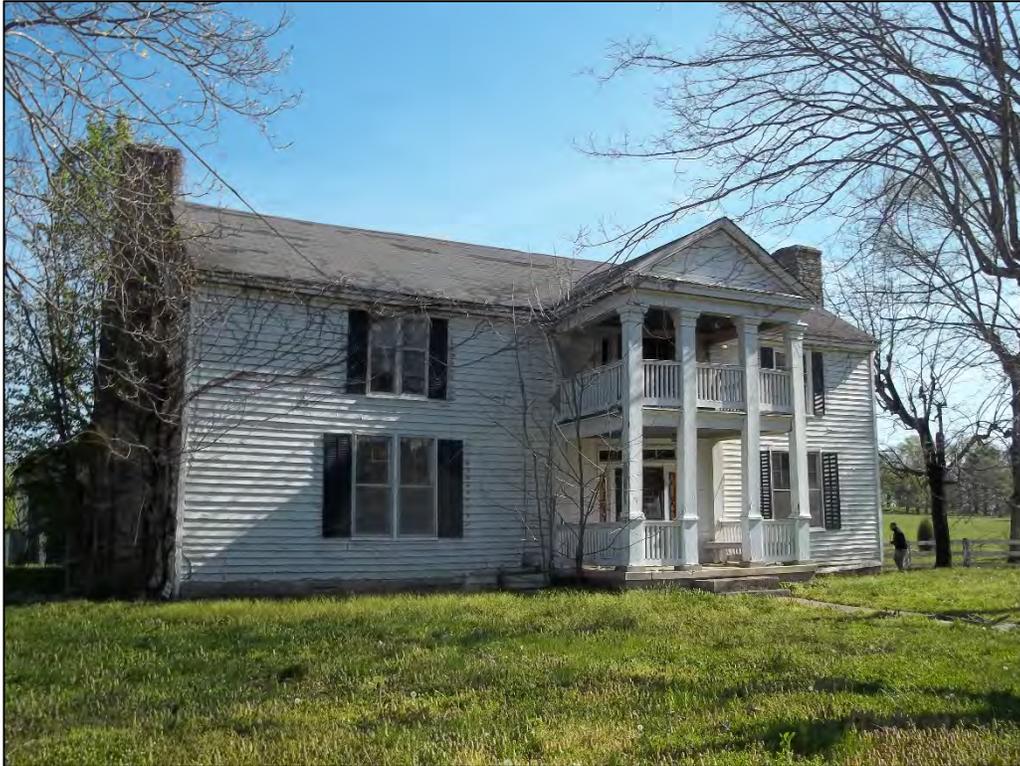
The south, or front, elevation of the original building is a two story, three bay structure with a gable roof and two exterior chimneys, one at each gable end. A full height Greek Revival entry porch is centered on the front façade. The roof is covered with asphalt shingles and is moderately pitched. Two of the bays on the upper story are 4/4 double hung windows with black, louvered, non-original shutters. The middle bay on the upper story is a double leaf door that opens to the second level of the porch. The lower level consists of two bays of double 4/4 windows with non-functioning shutters. Storm windows have been affixed to the windows on both levels of the south elevation. The double leaf door, the middle bay, is covered with a storm door and surrounded by a sidelight and a rectangular transom. The foundation shows evidence of repair over the years, and is a mix of stone and concrete piers. Some foundation in other parts of the elevation may be continuous.

South or front elevation

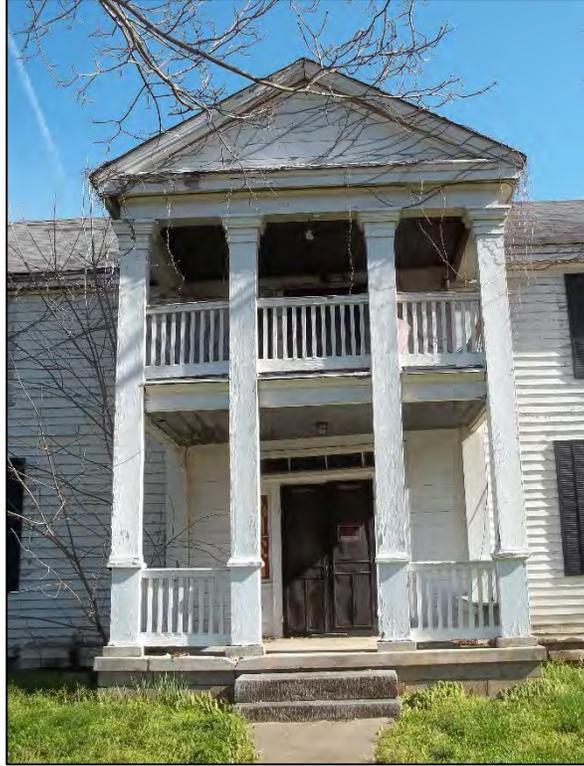
The full height Greek Revival entry porch has a front gable roof and four square columns with unadorned capitals. Both levels have a wooden balustrade. The concrete floor is supported by a concrete block continuous foundation. Two stone steps lead from the sidewalk to the porch. A wooden bench is built into the east side of the porch, and is in poor condition. The front gabled roof has a triangular pediment.

Full height porch on the South Elevation

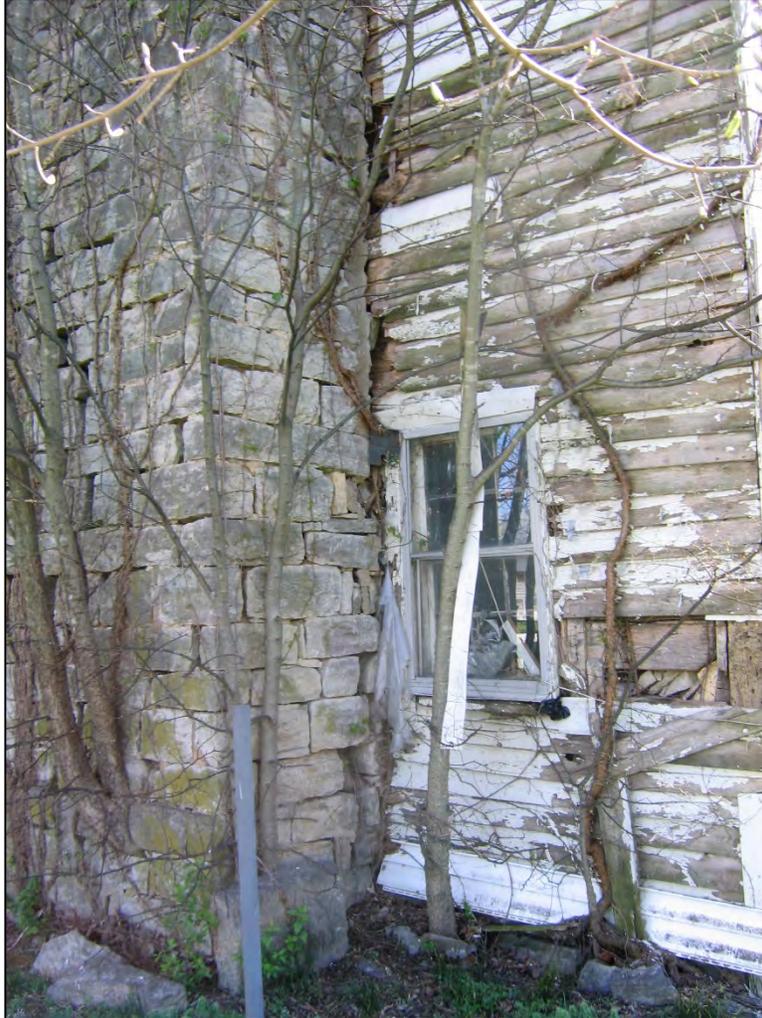
The west elevation has an exterior stone chimney and a side ell addition. This elevation has significant deterioration and damage, and it appears that several small trees are growing out of the chimney. Some weatherboarding has fallen from this elevation, exposing the original logs. The notching on the log ends, however, could not be determined.

The west elevation of the original house has a single bay with a 6/6 double hung window. The exterior stone chimney is in poor condition. There is extensive evidence of previous water damage at this elevation.

West Elevation of the original dwelling

Meadow Green Farm has been uninhabited for a number of years, and as a result, the house has suffered a significant amount of deterioration. There is evidence of graffiti and vandalism in the house. There is also significant evidence of rodent and insect infestation. If the property owner wishes to rehabilitate or restore the property, it is suggested that a historic preservation architect or contractor be consulted.

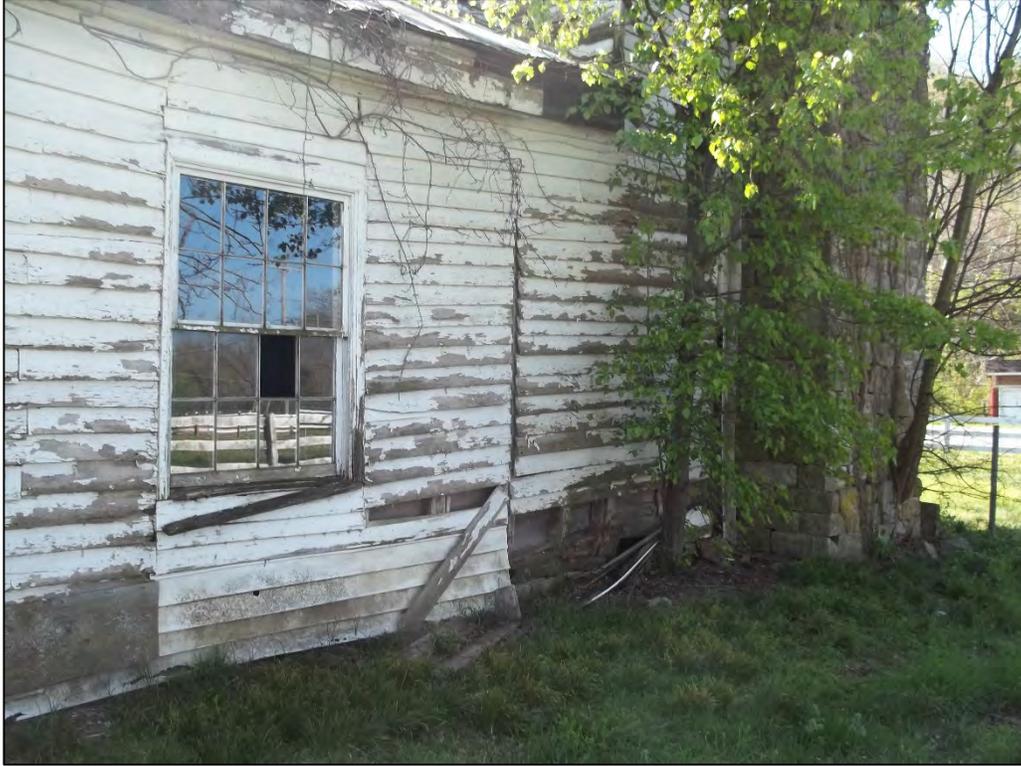
The location where the ell addition adjoins with the original structure on the west elevation.

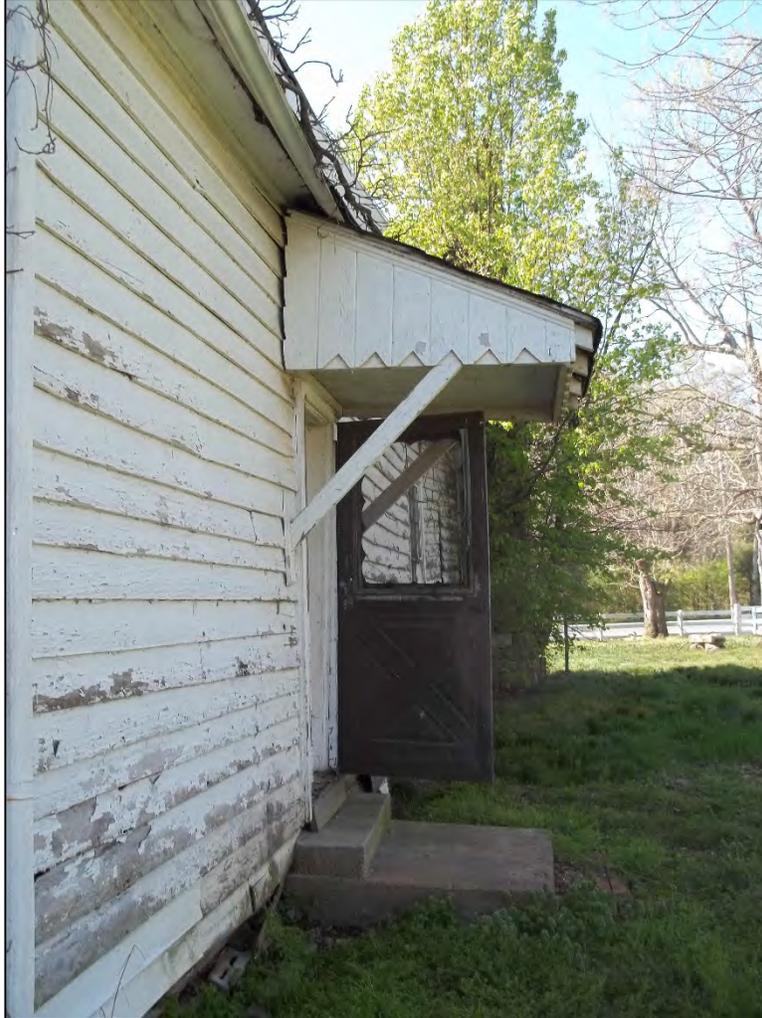
The ell addition has a metal seamed roof, weatherboarding, and a concrete block foundation. The west elevation on this addition has two bays. One bay consists of an 8/8 window and the second bay is a single leaf door with a storm door attached. There is a concrete stoop porch and shed roof covering over the door. The west elevation of the ell addition is in poor condition.

Porch of the ell addition on the west elevation

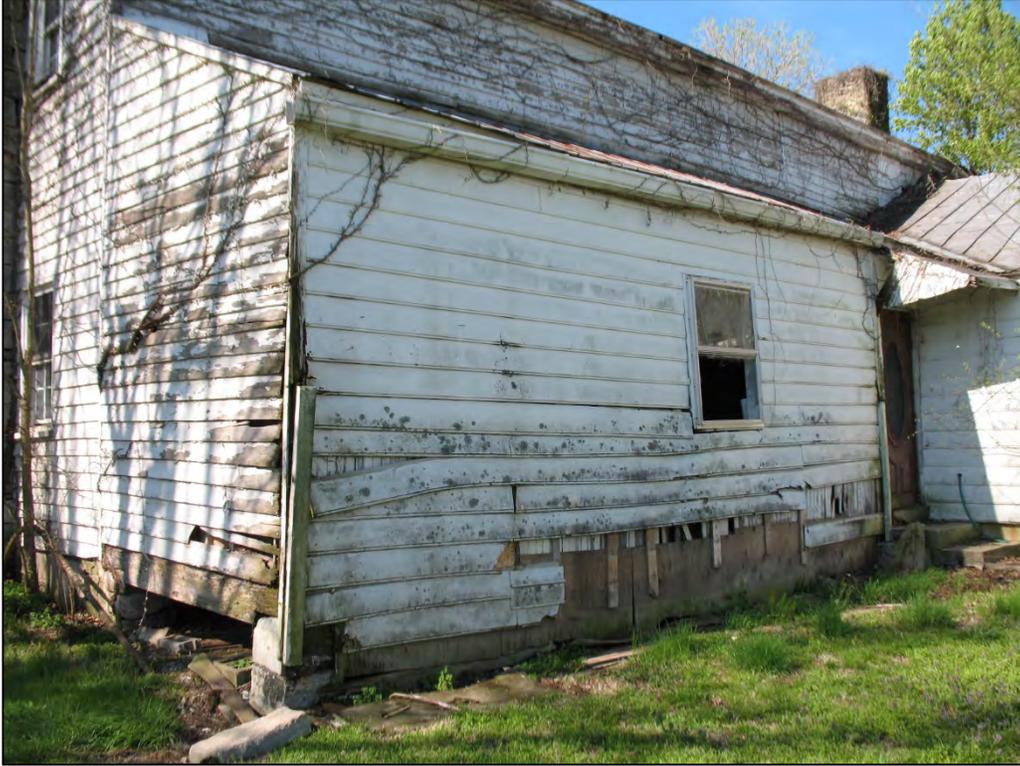
Shed rear addition. At the bottom left of the picture one of the logs beneath the weatherboard is visible.

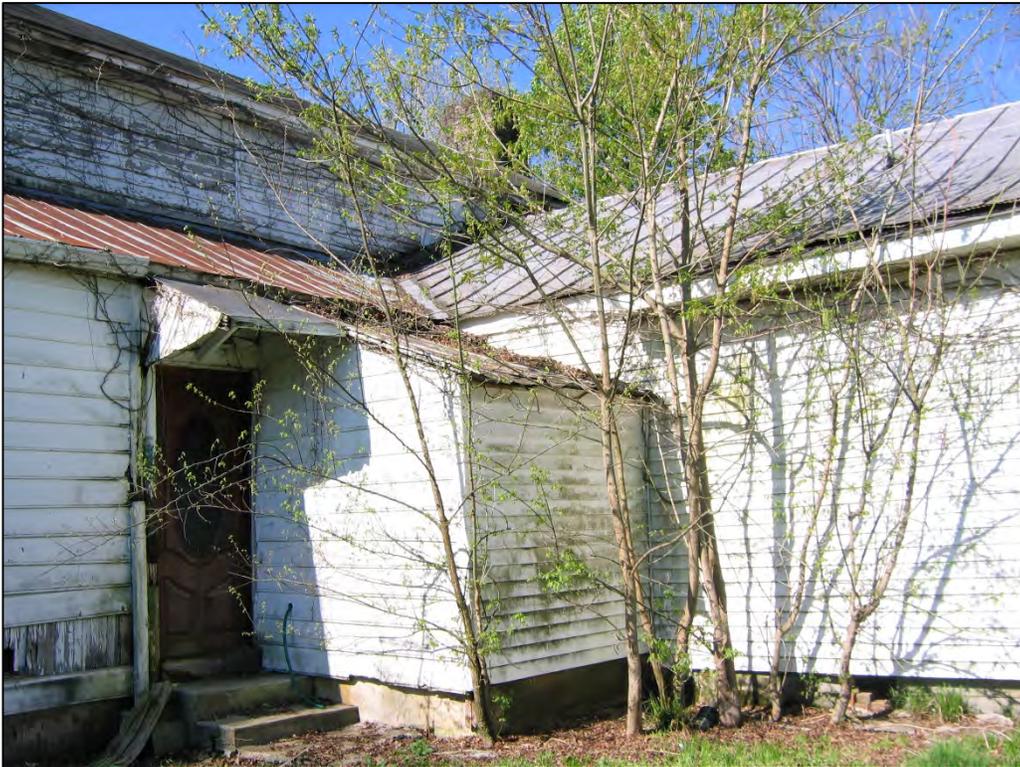
The place where the ell addition, shed rear addition, and main house meet.

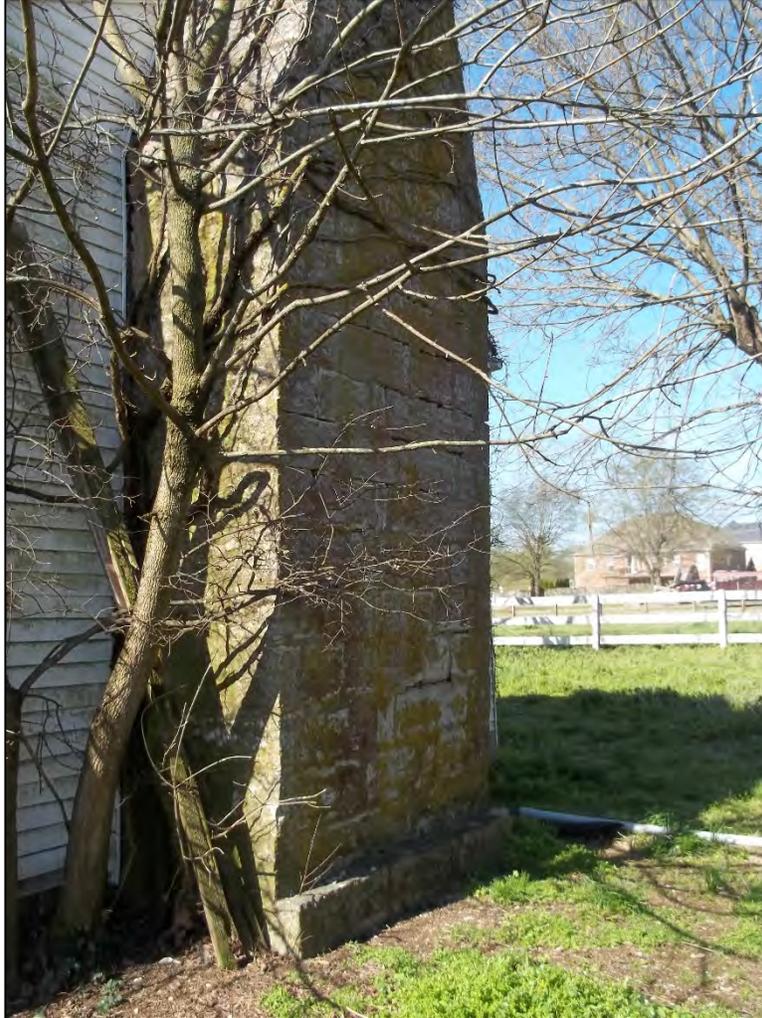
Exterior chimney on the north elevation of the ell addition

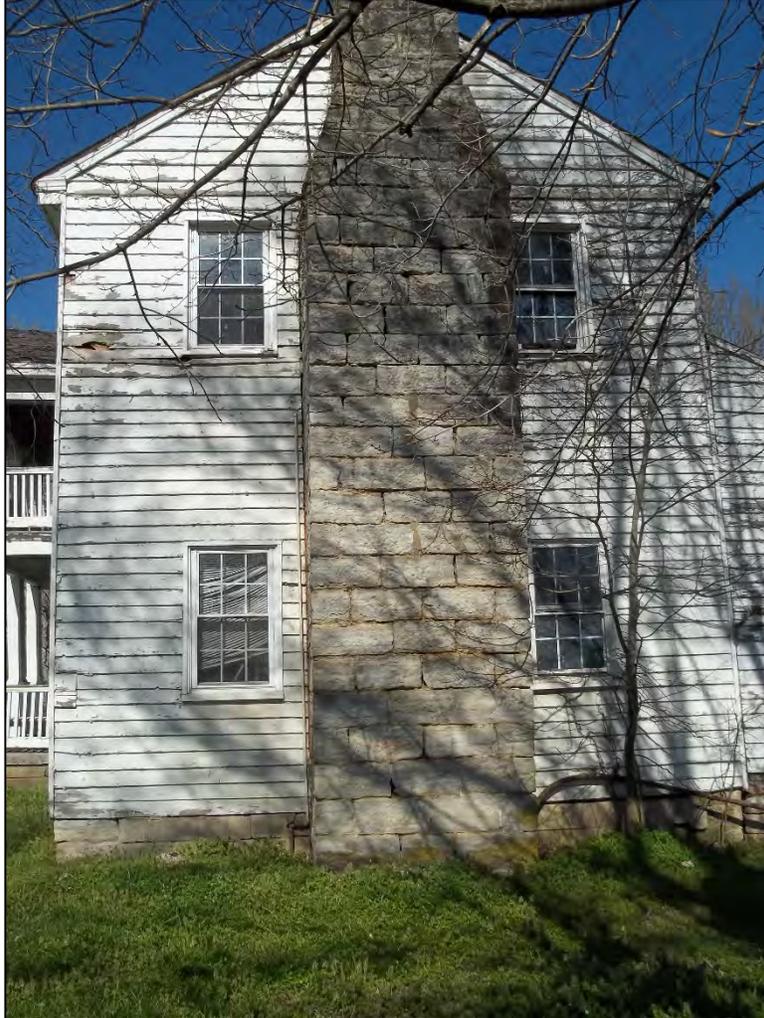
The east elevation of the original dwelling has an exterior stone chimney, two bays of windows on each elevation, and a concrete block foundation. The windows are 6/6 double hung windows. Although some of the weatherboards are damaged on this elevation, it is in better condition than the west elevation.

East elevation of original structure.

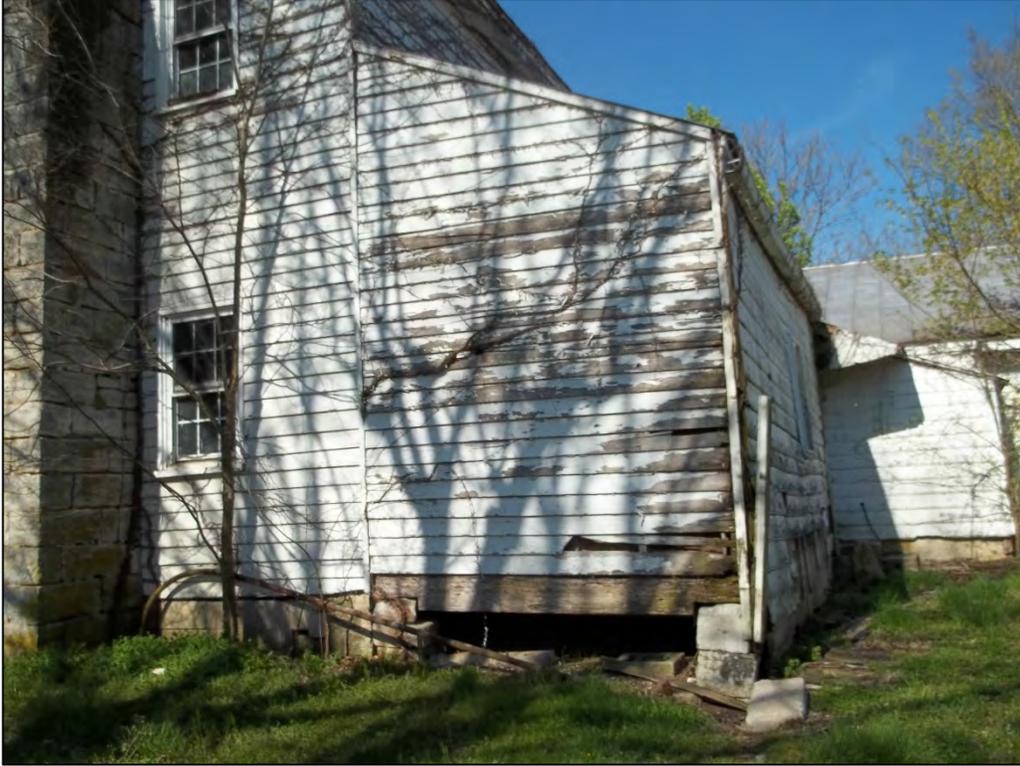
The east elevation of the shed rear addition sits on a pier foundation. Some of the weatherboards are damaged or missing, showing the logs beneath.

East elevation of the shed rear addition.

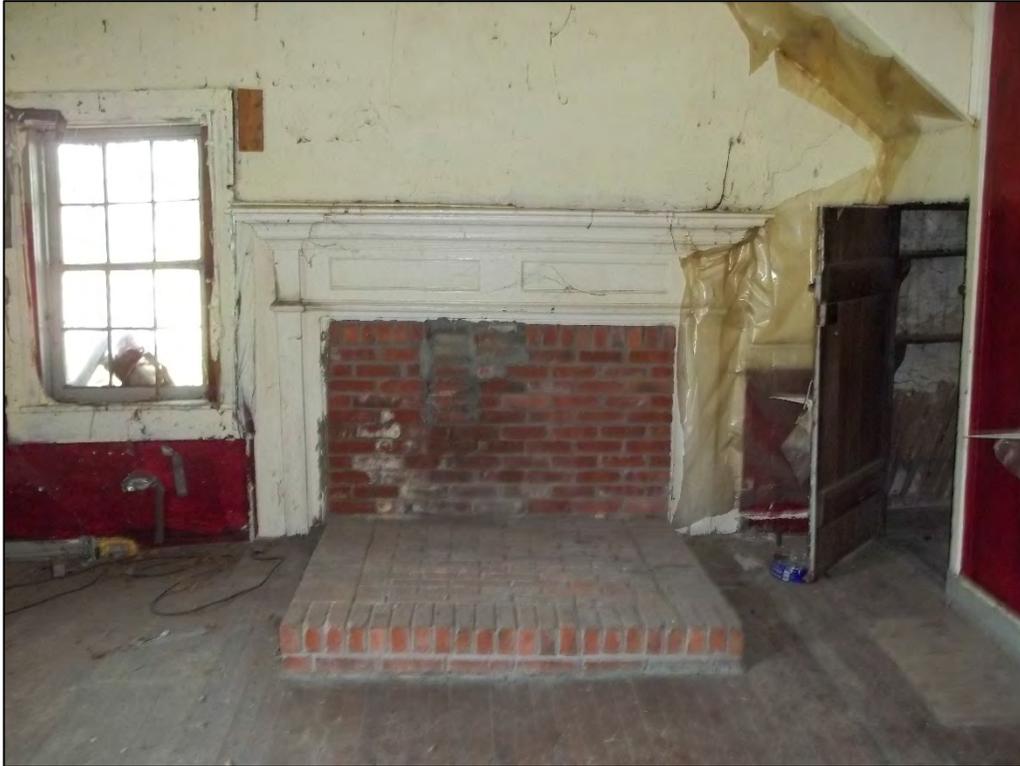
Fireplace in the West Room. The under-stair storage for the box stairwell is located to the right of the fireplace.

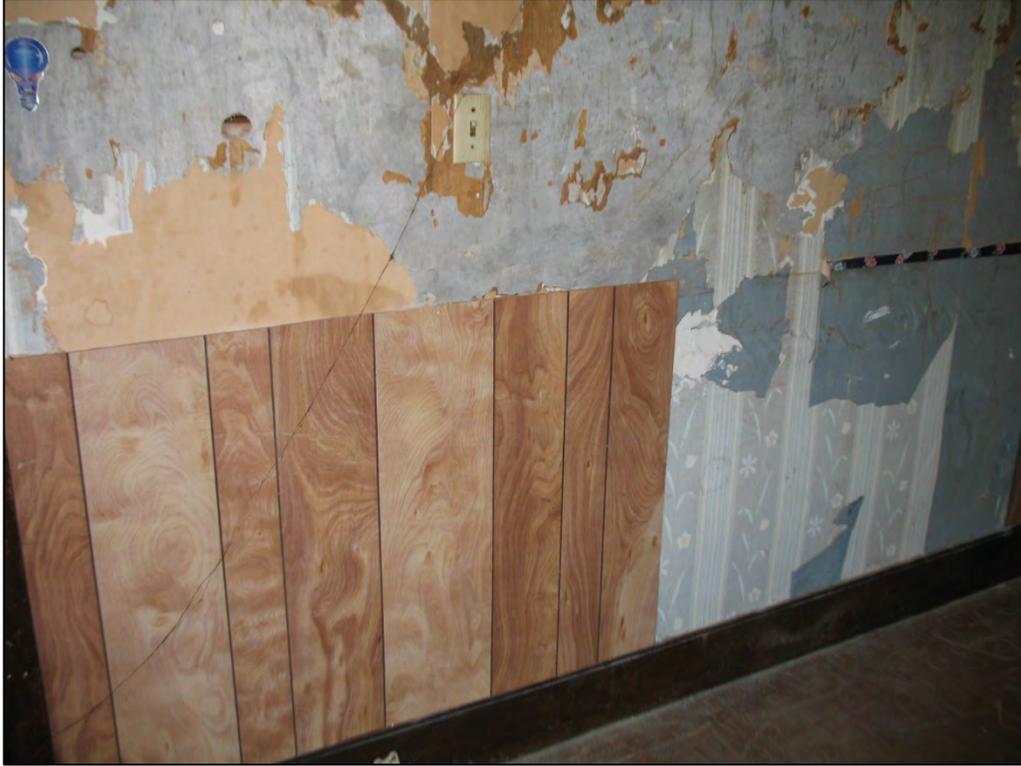
Detail view of the west wall in the east room, showing the half-paneled walls and the wallpaper remnants.

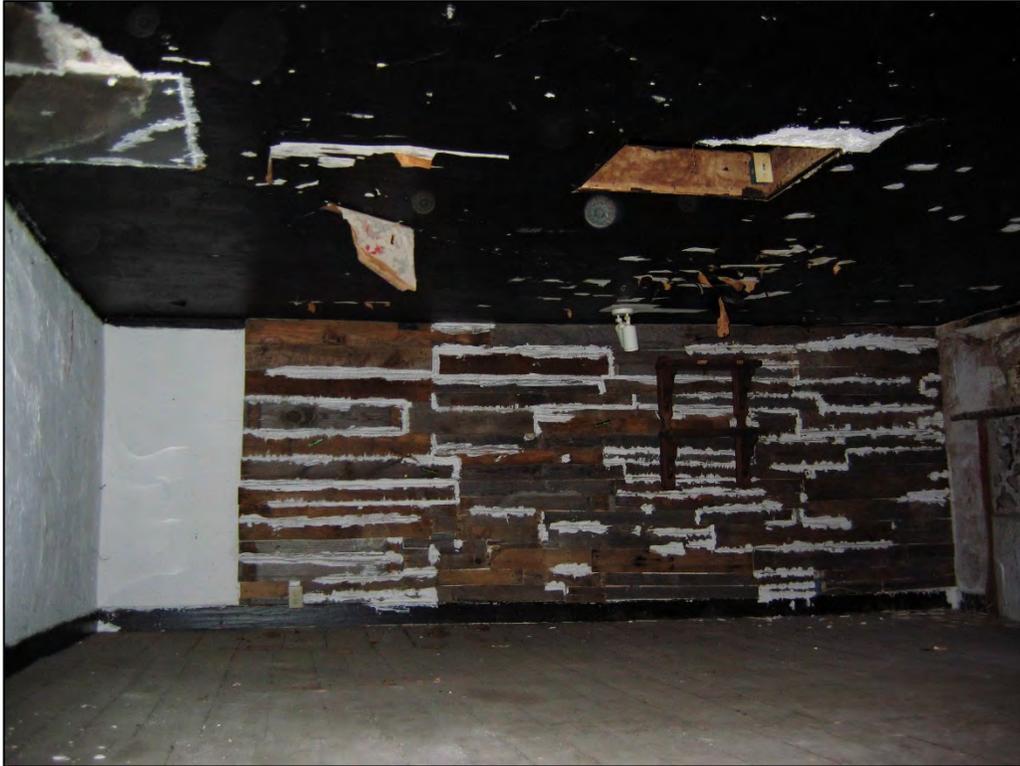
The west bedroom is only accessible by the box staircase leading from the lower level west room. The ceiling may be drywall, the walls are log and drywall, and the floor is log. There is a decorative mantel on the south wall (or front elevation). There is graffiti on the walls.

West bedroom.

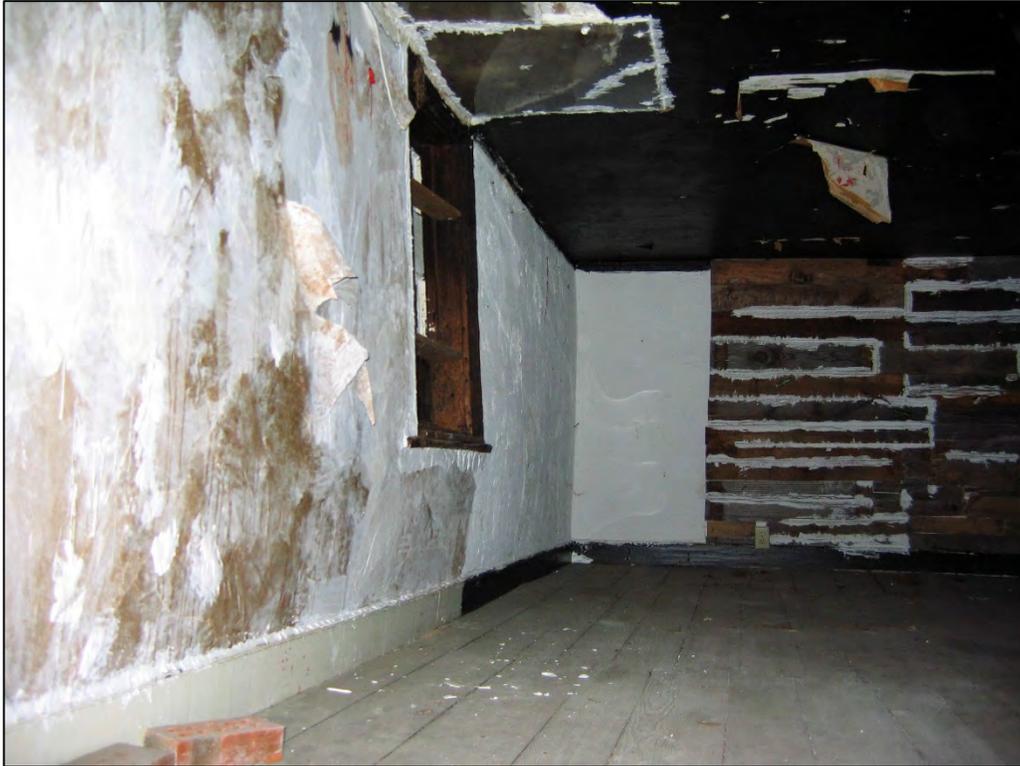
North wall of the west bedroom. This window does not look into anything as the ell addition is located behind this wall.

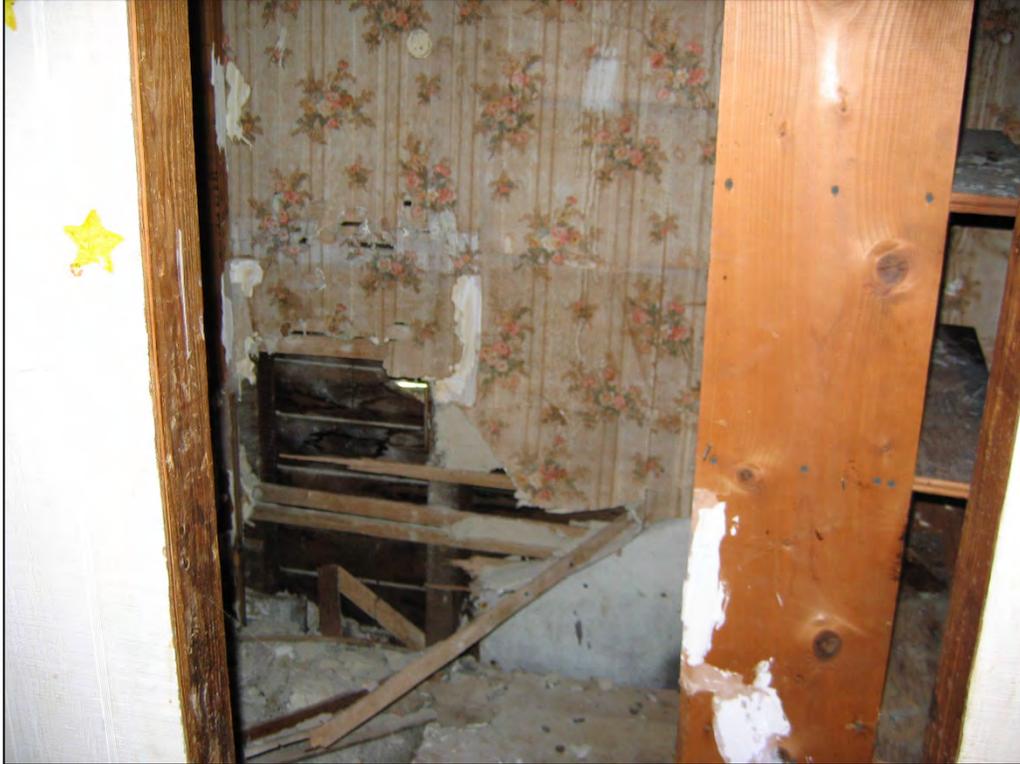
Interior of the closet in the east bedroom. Note the logs visible beneath the peeling wallpaper.
