MEADOW GREEN FARM SUMNER COUNTY, TENNESSEE SITE DOCUMENTATION

May 2014

**A Public Service of the
Tennessee Civil War National Heritage Area**

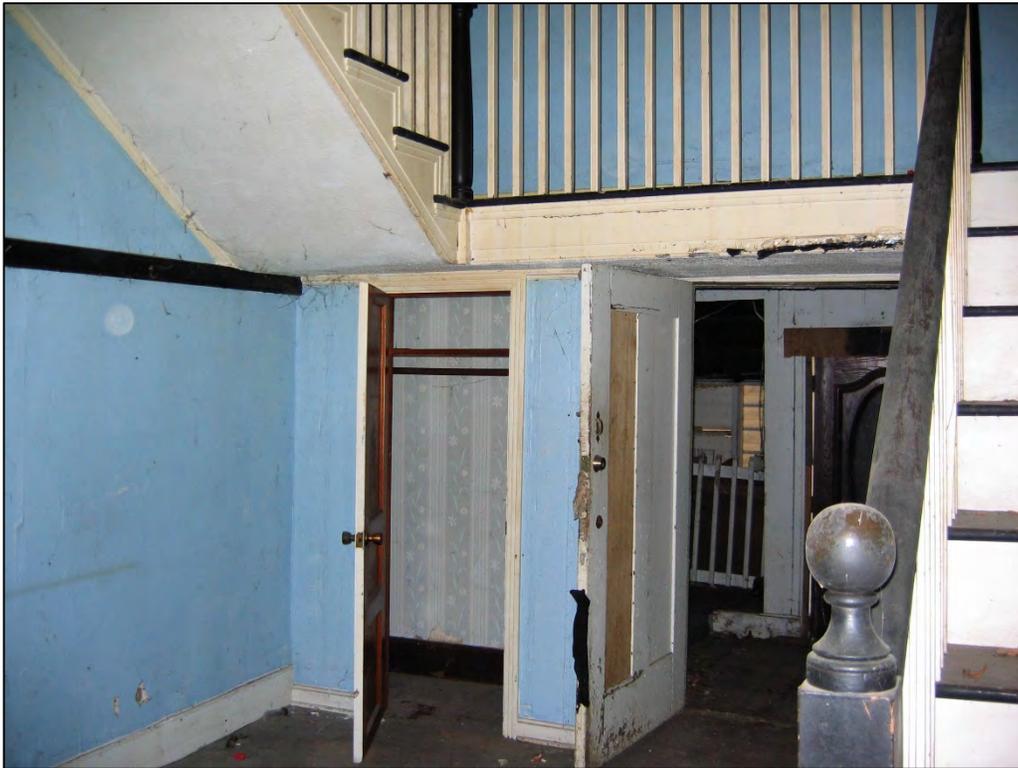
Entry

The entry contains a stairway to part of the upper level of the house. It has a drywall ceiling, plaster walls, and wood floors. The newel posts and top railings appear to be walnut. There is molding at the baseboards and crown molding as well. There are two closets beneath the stairs. There is a step up to the west room. This room has four doors – one on the front elevation of the house, one to the west room, one to the east room, and one to the shed rear addition. The front entry double leaf door has sidelights and a rectangular transom.

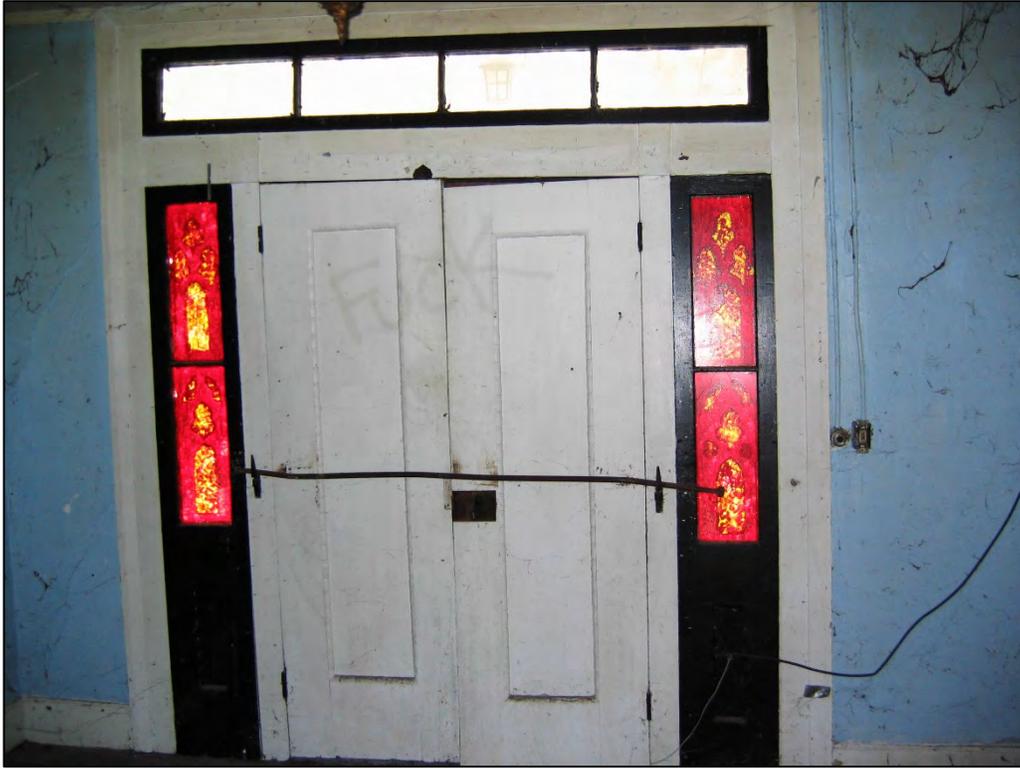
Entrance door to the house with sidelights and a rectangular transom.

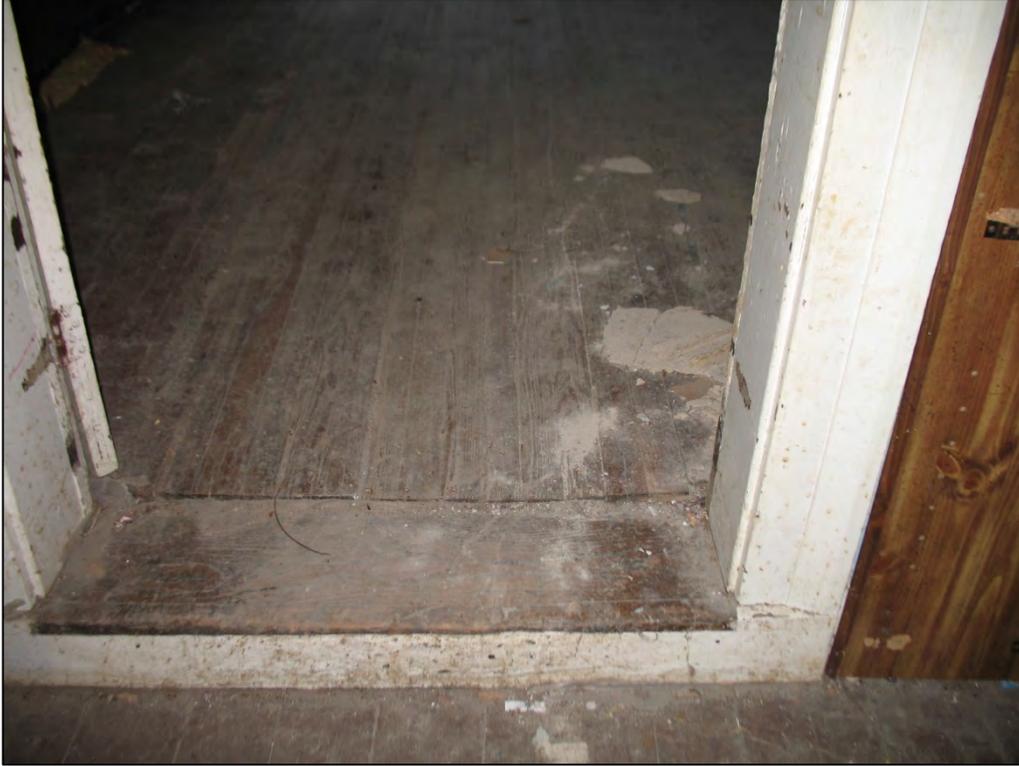
This may be the core of the original house. The evidence suggests that the house may have originated as a two-story single pen log dwelling, as evidenced by the step up from the entry hall to the room, the box staircase in the corner which is the only entry point for the upper west room, and the placement of the bays for the windows and doors.¹

Step up from the entry to the west room, lower level.

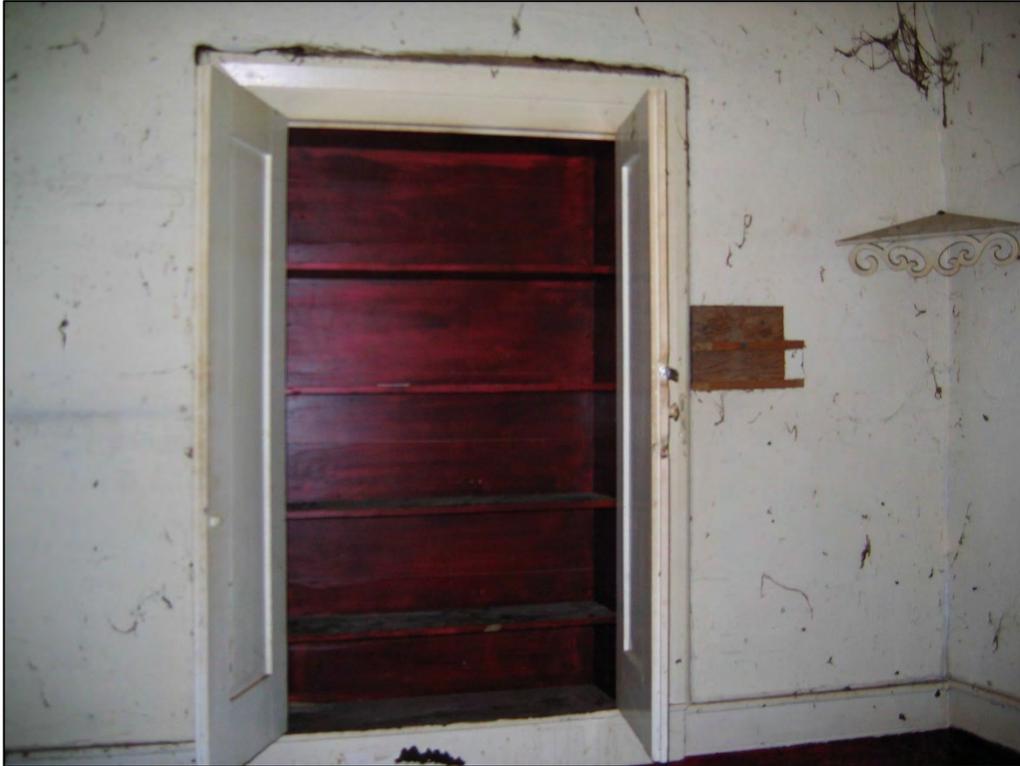
Built in bookcase located right of the door on the front elevation in the West room.

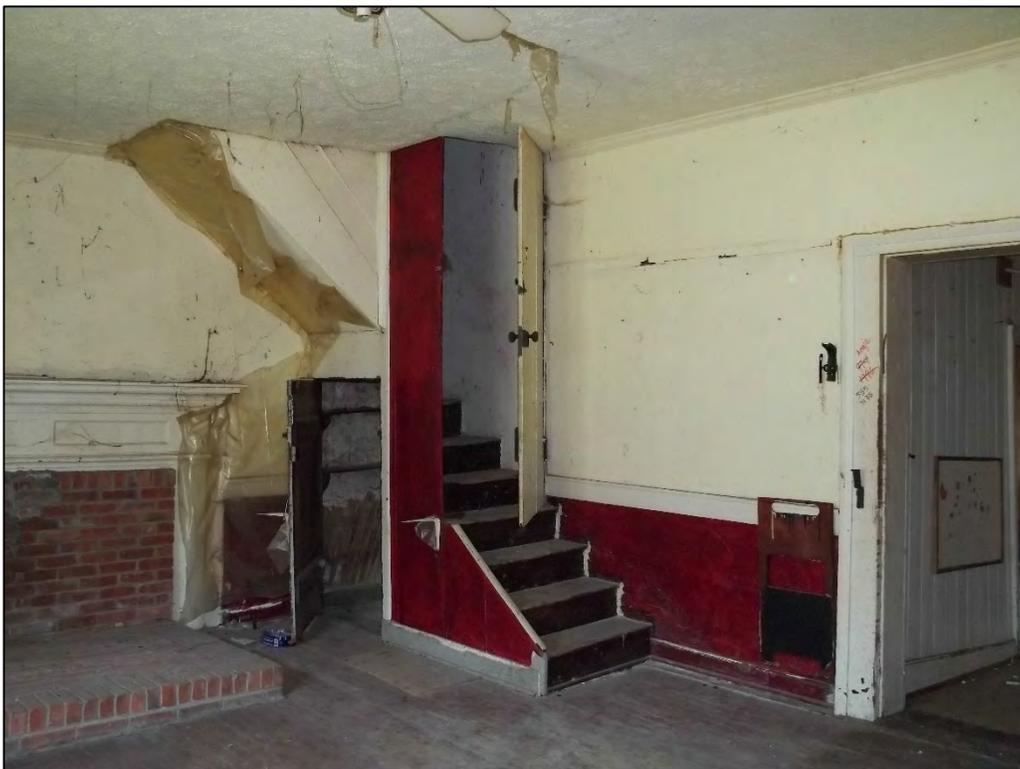
There is a box staircase in this room, the only entrance to the West Room, Upper Level.

Box stairwell leading to the upper west room.

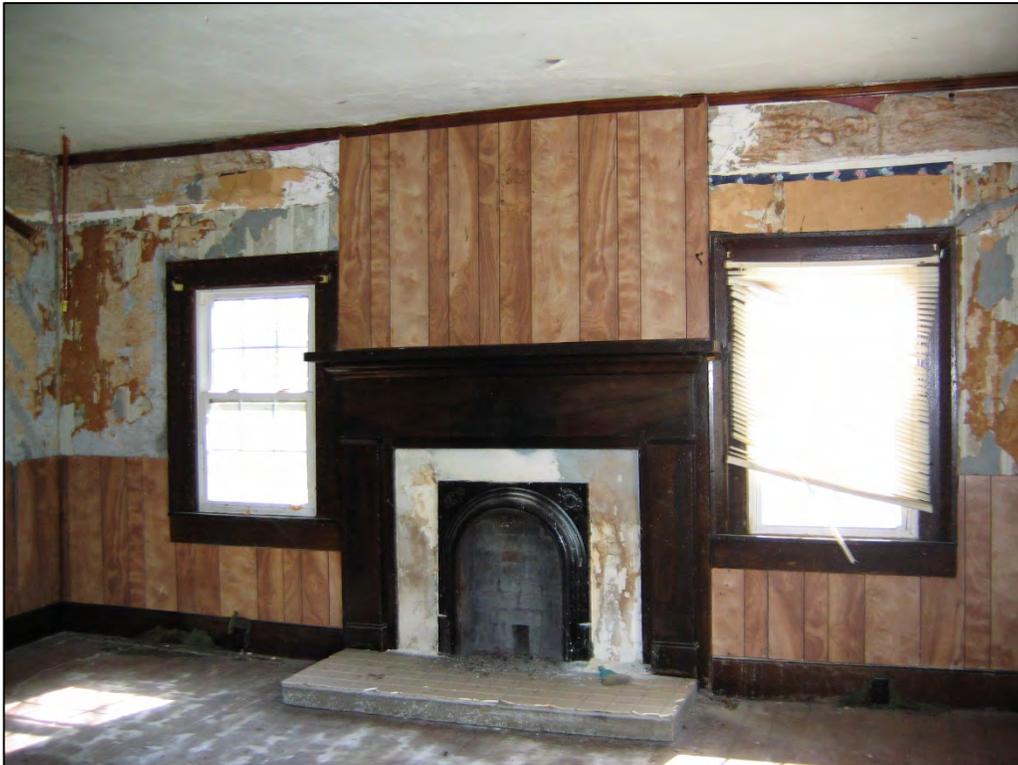
The east room, lower level, measures 17'8" by 17'2". The ceiling is drywall, the walls are drywall with remnants of wallpaper affixed to the wall, and the floor is wood. The room is paneled in wood on the bottom half of all of the walls. There are baseboards and crown molding in this room. A ceramic tile fireplace is located on the east wall, and the wooden mantel is 6'4" long. It appears the fireplace was converted to a coal-burning unit, possibly in the late 19th or early 20th century.

East room, lower level.

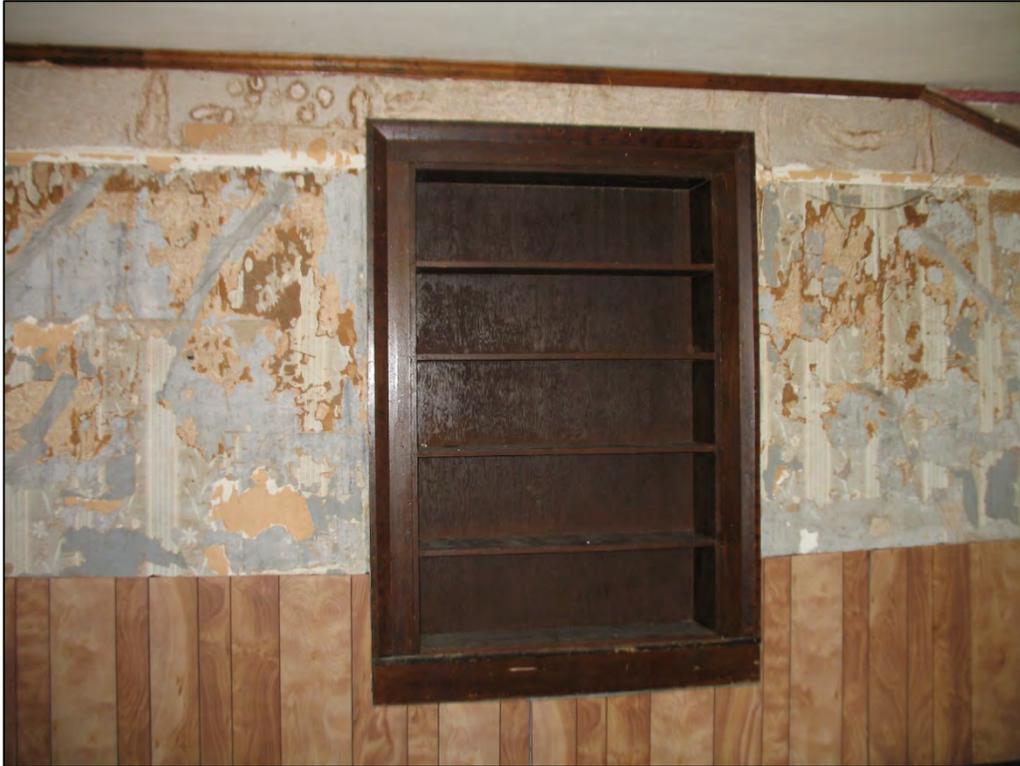
Built in bookcase on the north wall, possibly the site of a former window.

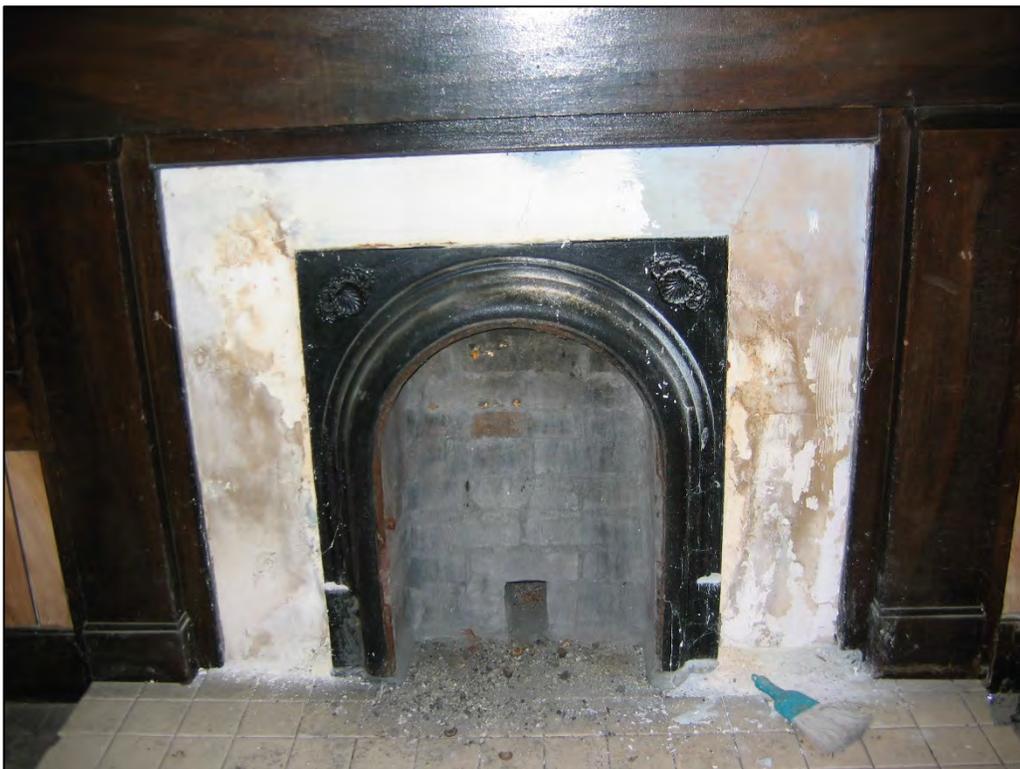
Fireplace detail in the east room.

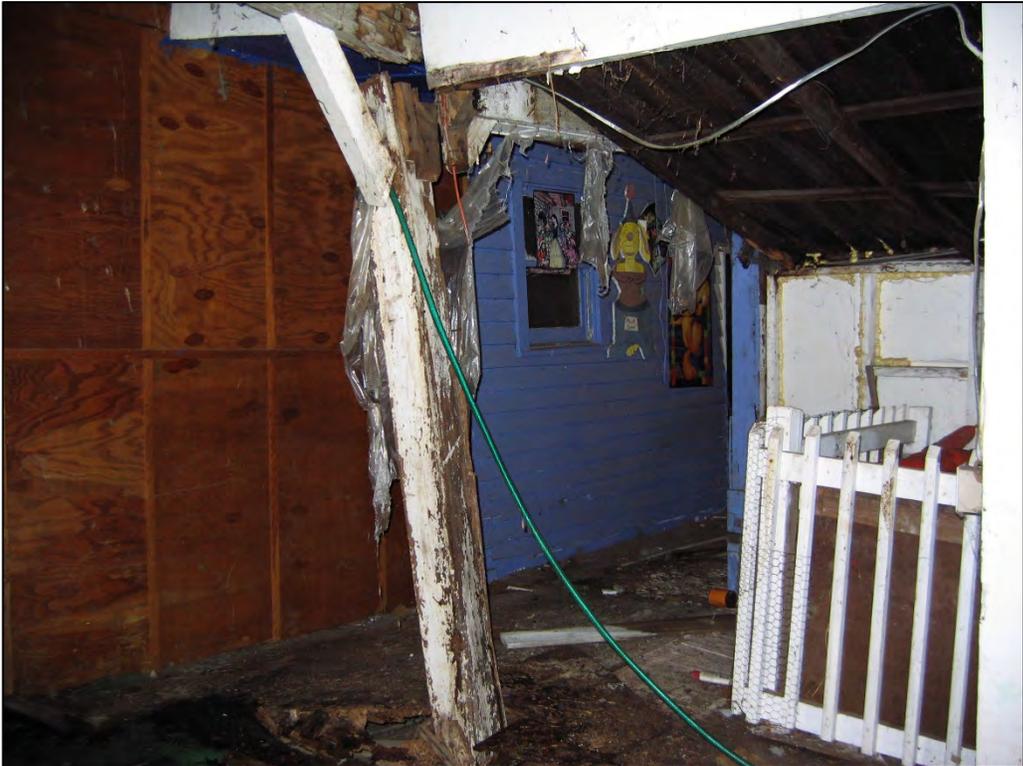
Shed rear addition

The shed rear addition was not documented extensively due to safety concerns.

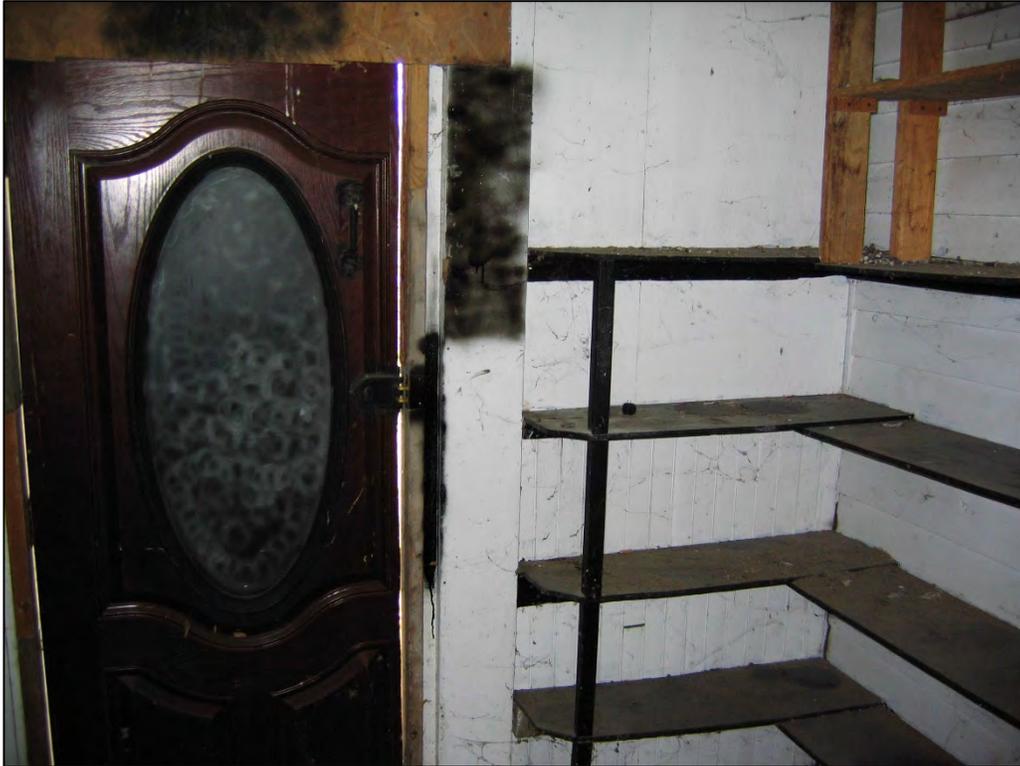
Rear door in the shed rear addition leading outside.

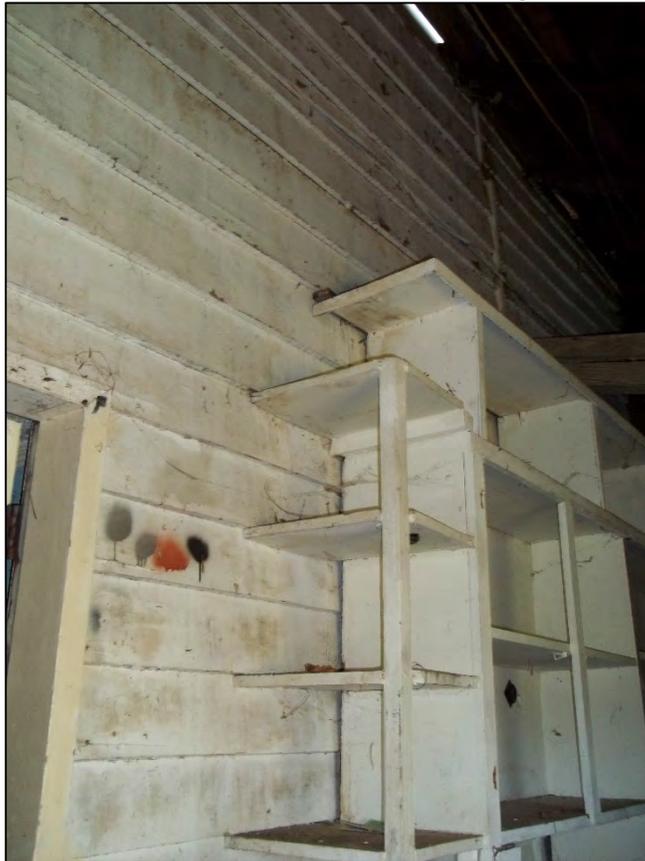
Shed rear addition. This is the wall the space shares with the east room.

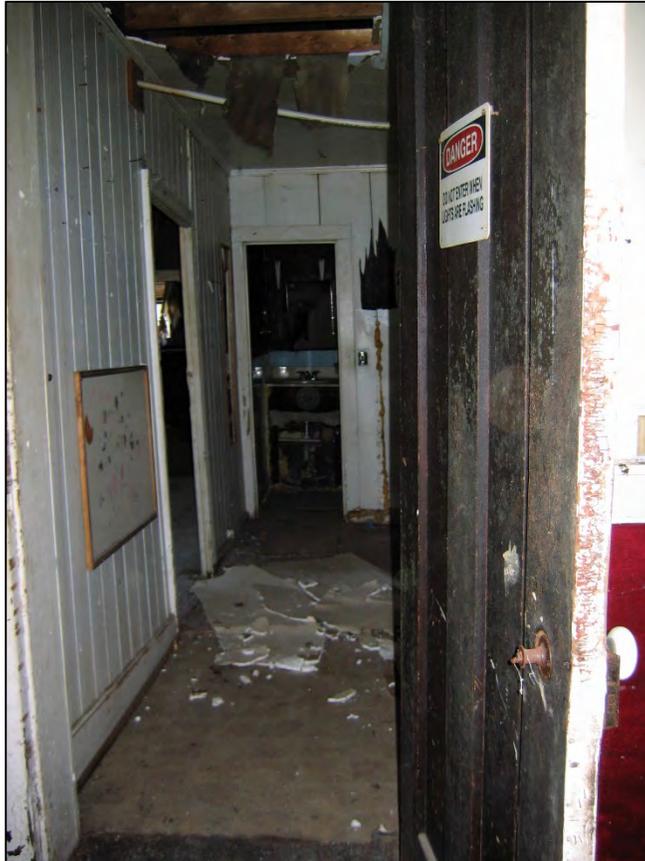
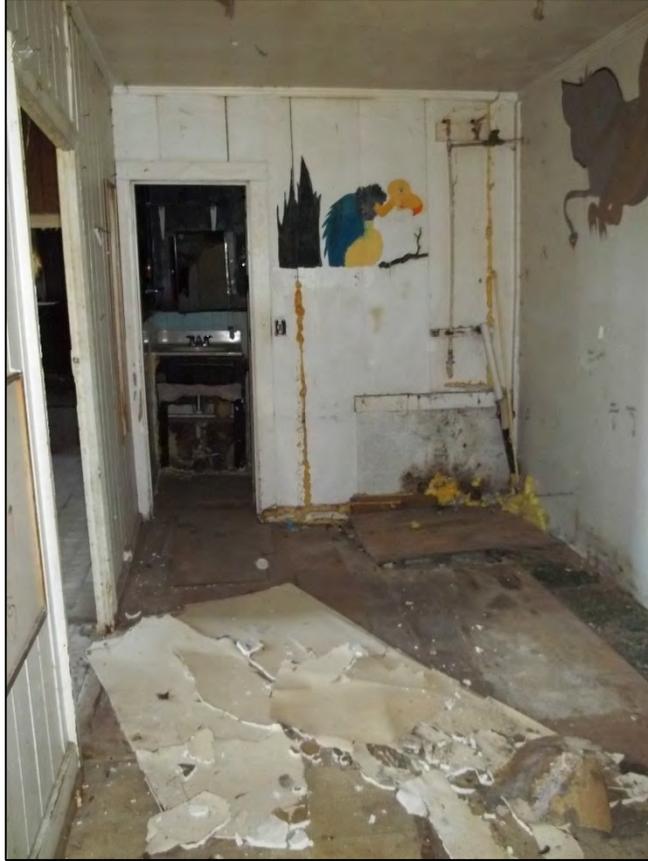
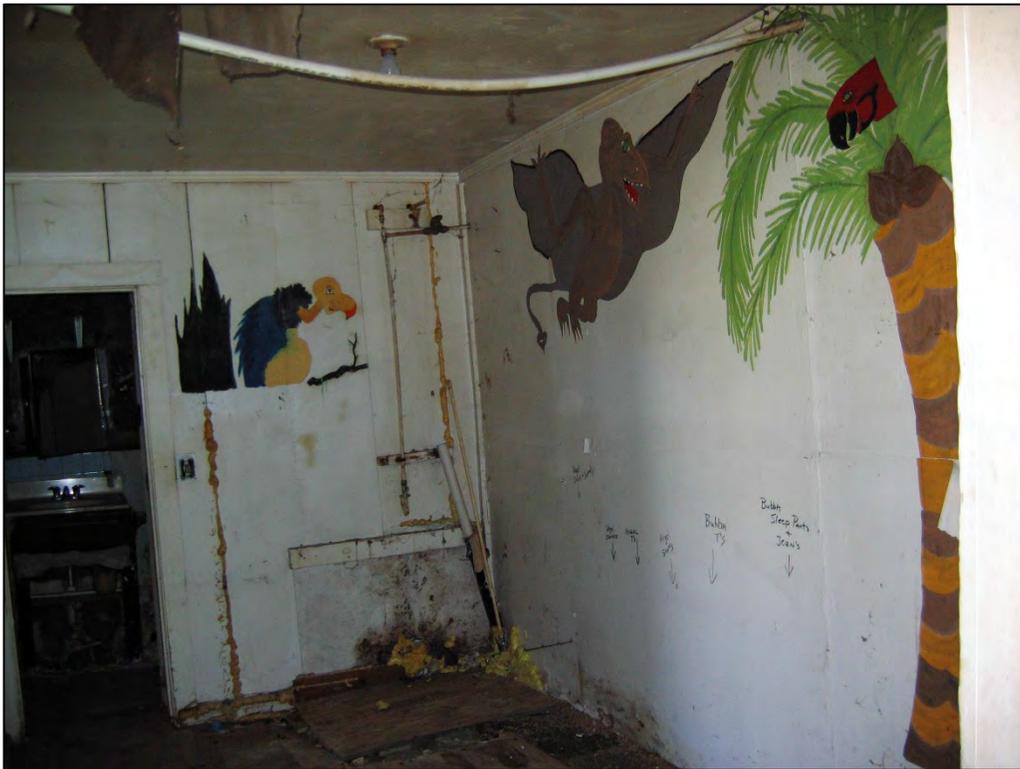
The ell addition was not extensively documented due to safety concerns. This addition contains a bathroom and a kitchen. It is in poor condition.

Looking into the ell addition.

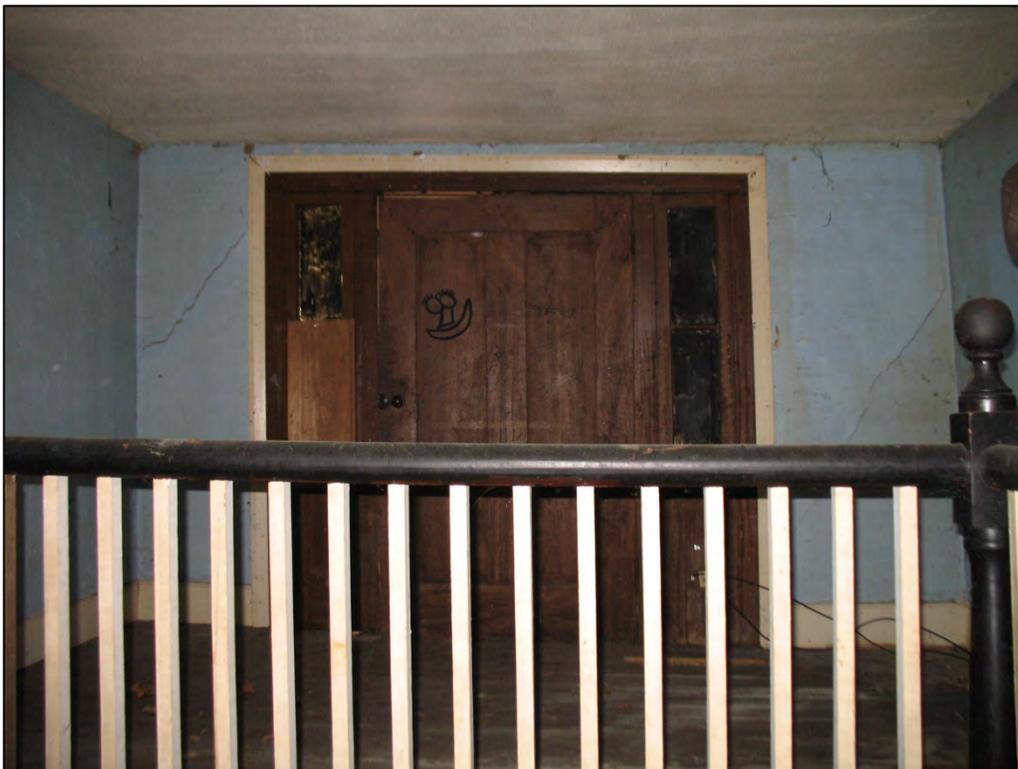
Upper landing

The upper landing has an acoustical (or “popcorn”) ceiling, drywall walls, and wood floors. There is a 7.5” baseboard around the room. A single leaf door to the balcony of the full height front porch measures 7’5” across and the door measures 3’7” across. Sidelights are present on either side of the door. The door has an agate/cat’s eye door knob. The balusters and newel posts on stair rail are walnut and the balusters are painted white. Other than the stairway leading from the lower level, the only other entry or door is to the east bedroom. There is no access from the landing to the upper west bedroom.

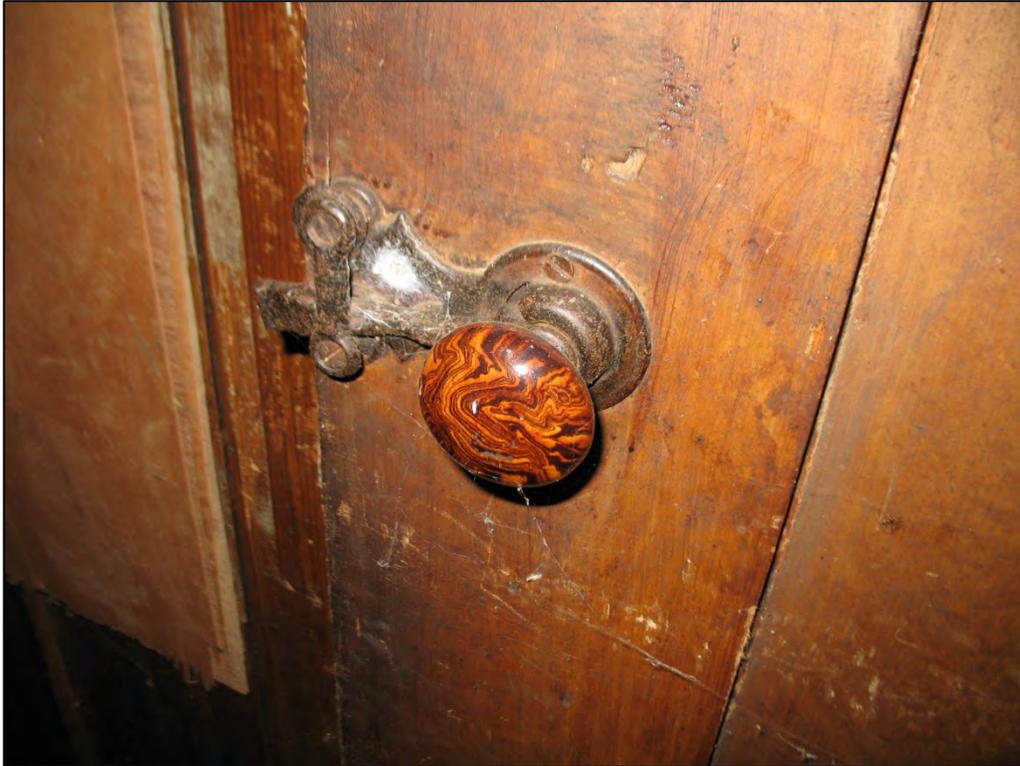
Detail of the doorknob on the upper landing door leading to the balcony.

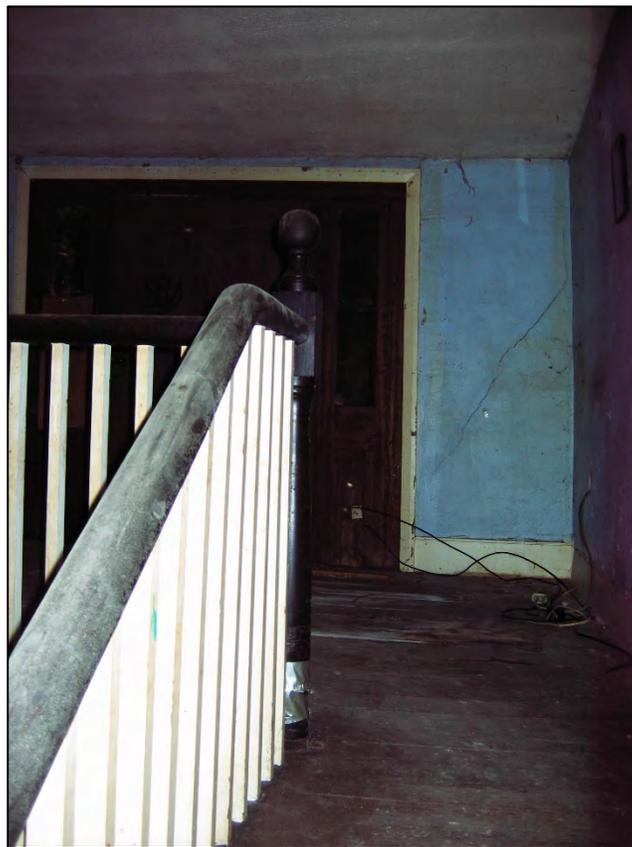
View of the upper landing from the stairwell.

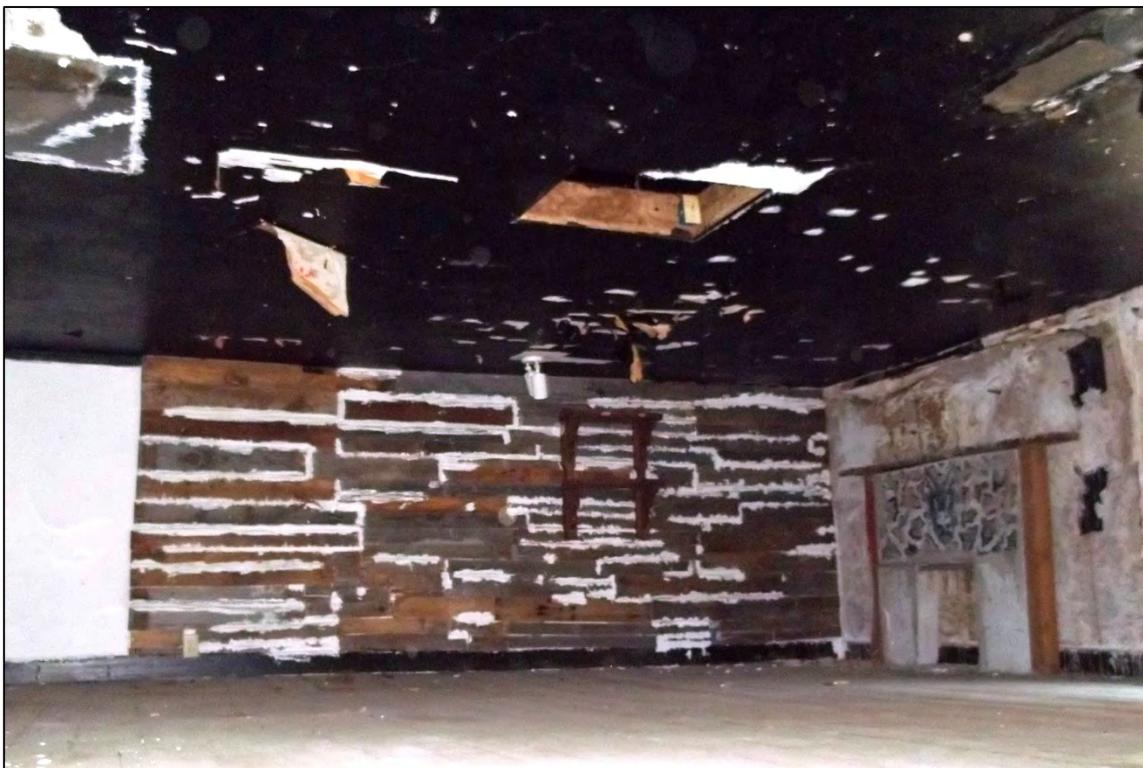
The west bedroom is only accessible by the box staircase leading from the lower level west room. The ceiling may be drywall, the walls are log and drywall, and the floor is log. There is a decorative mantel on the south wall (or front elevation). There is graffiti on the walls.

West bedroom. The decorative mantel can be seen to the right in the picture.

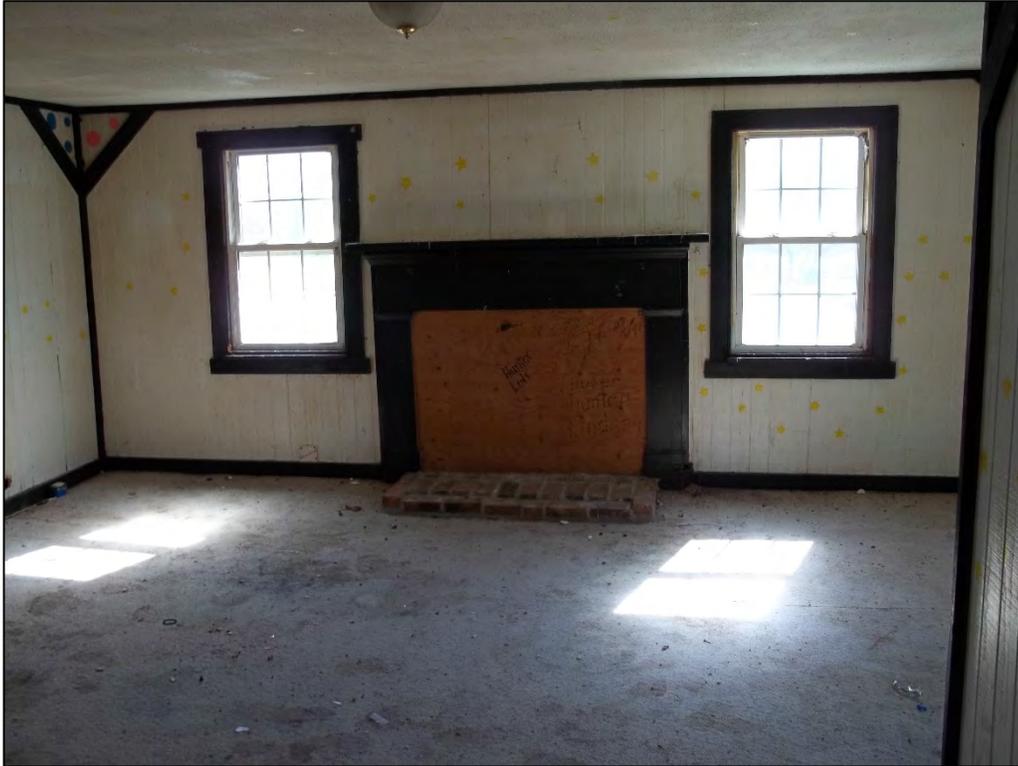
The east bedroom has an acoustical (or “popcorn”) ceiling, wood paneled walls (painted white), and a carpeted floor. There is a baseboard around the room, and crown molding at the ceiling. A closet has been built into the room on the south wall. A boarded fireplace is located on the east wall, with a wooden mantel and brick hearth.

East bedroom. Note the fireplace with the brick hearth.

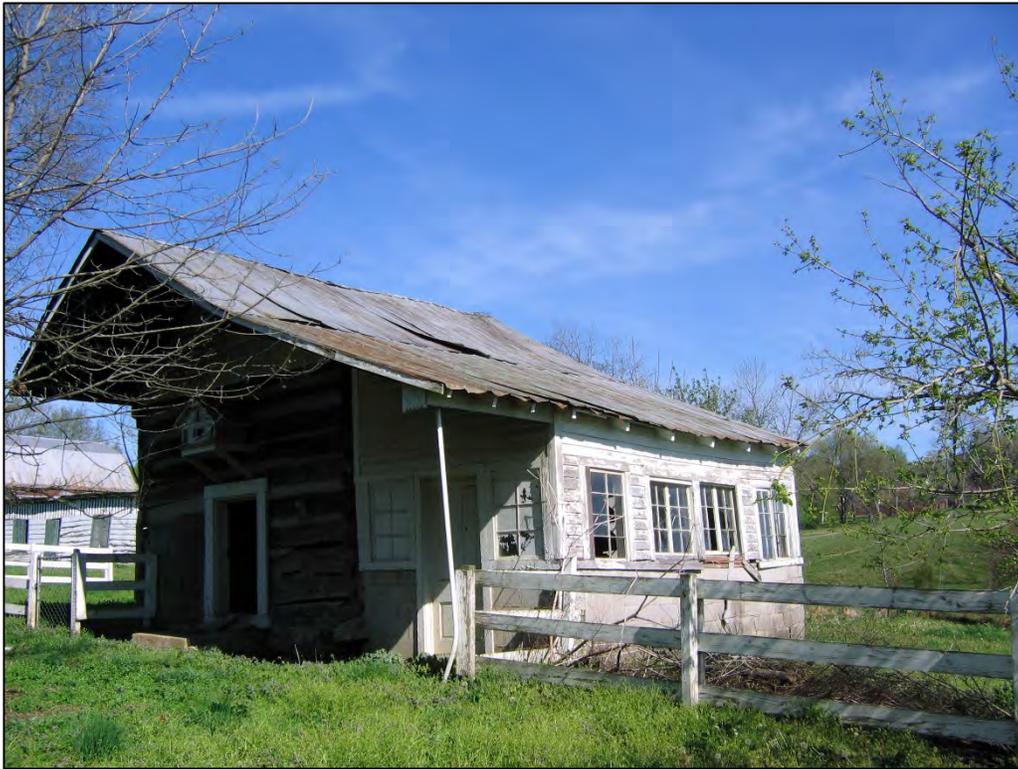
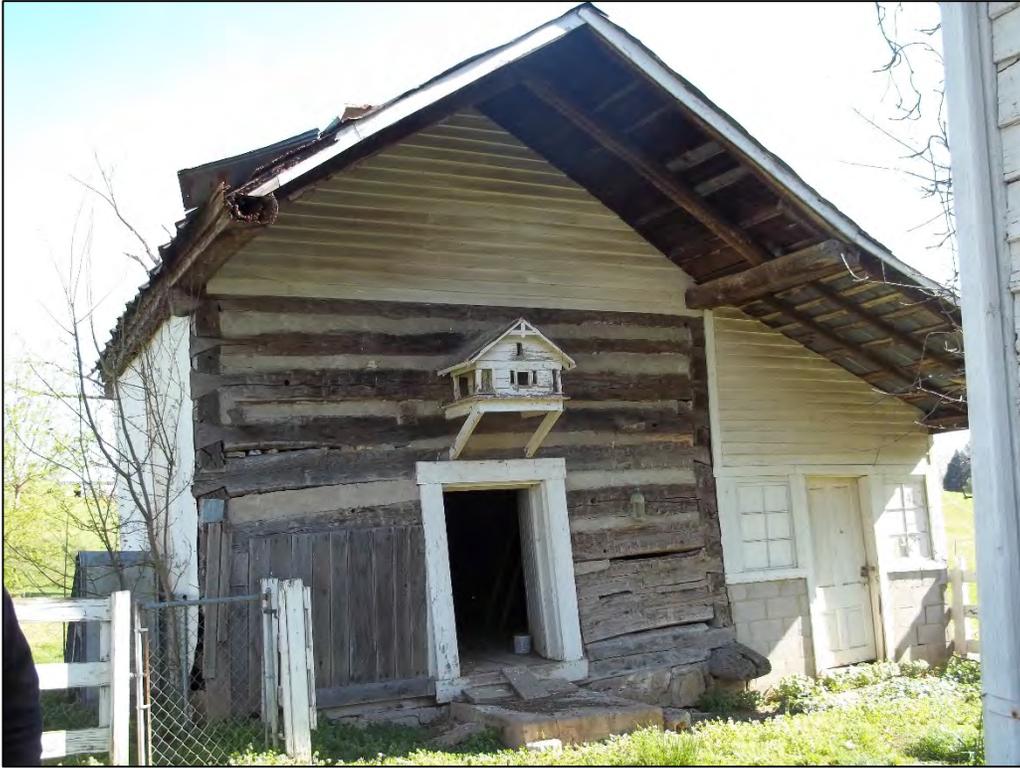
Smokehouse

There is one outbuilding at the site, and it is located behind the main house. It is a log smokehouse with a front gable seamed metal roof. The notching on the logs are half-dovetail. A concrete stoop porch is attached to the front of the structure and is a later addition.

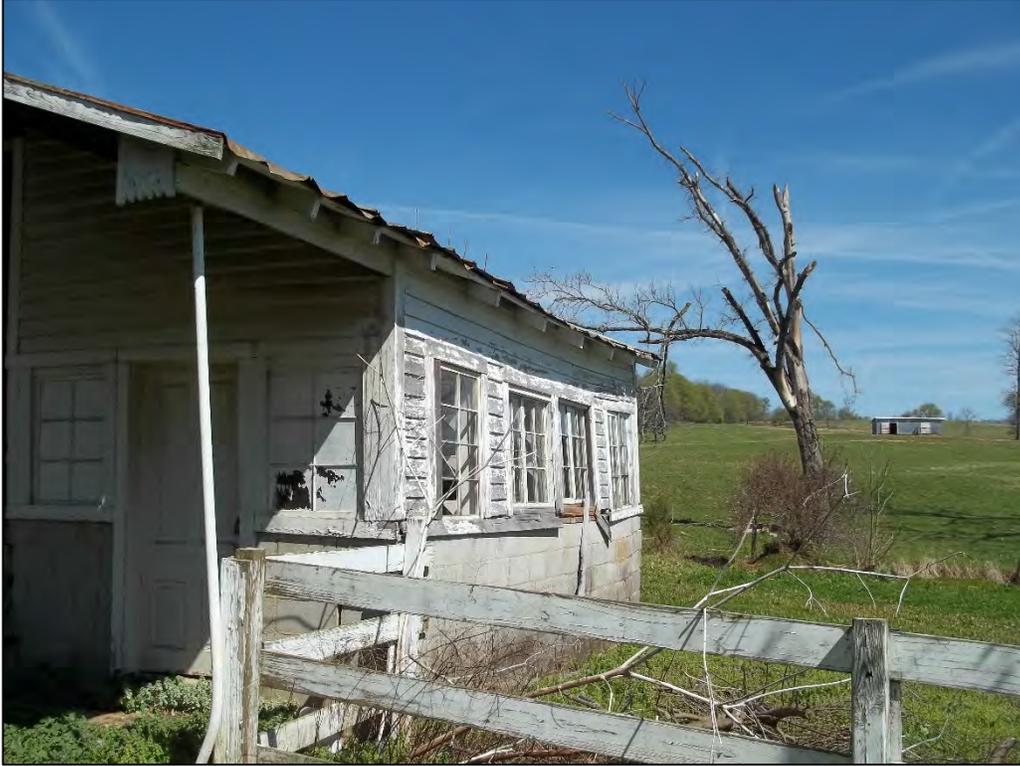
There is a later side addition that is concrete block and weatherboard. There are two six pane single hung windows on this addition as well as a single leaf door. The wooden rafter ends are exposed on the east elevation.

Side addition on the smokehouse.

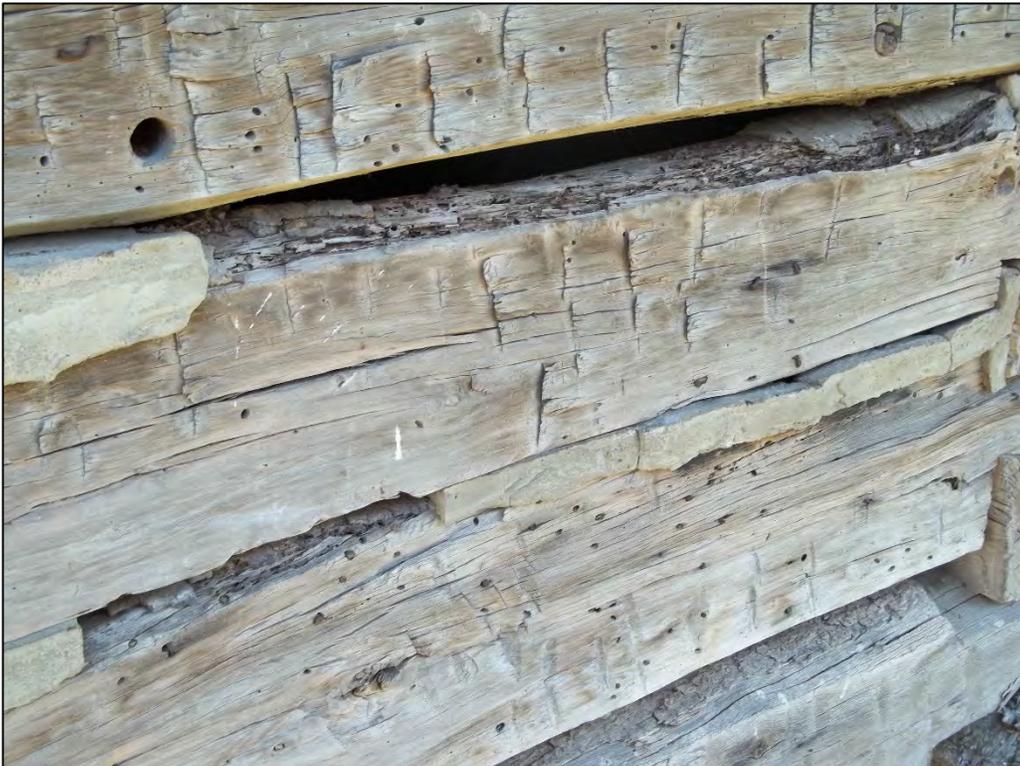
Detail of the log walls of the smokehouse.

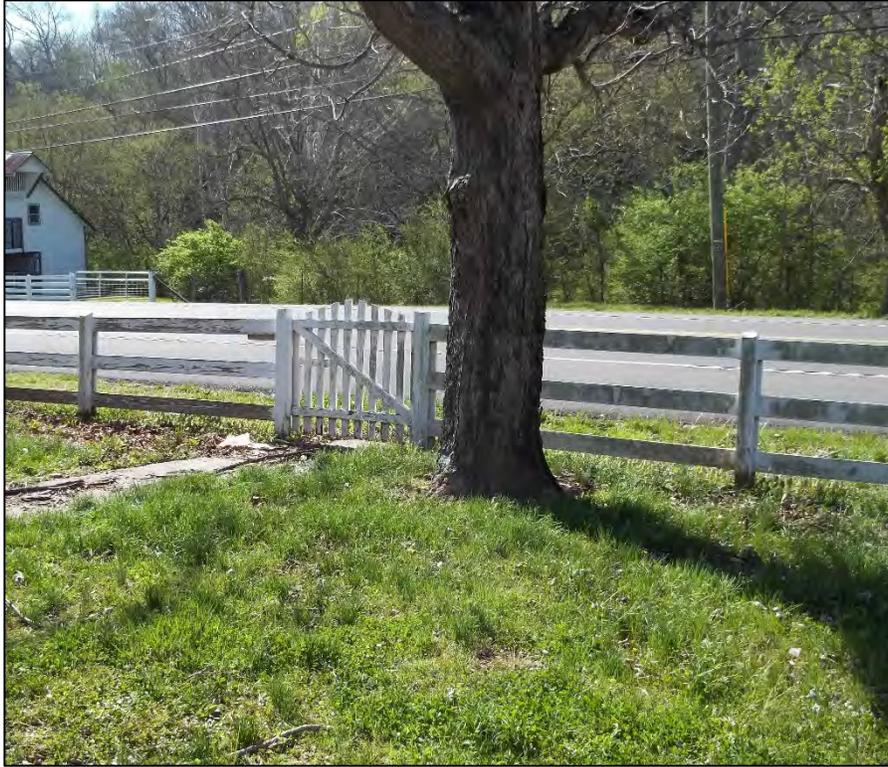
There is a white wooden fence at the front of the property at the road. A wooden gate opens to the concrete sidewalk which leads to the house. A stone highway marker stands between the fence and the road.

Wooden fence and gate at the front of the property.

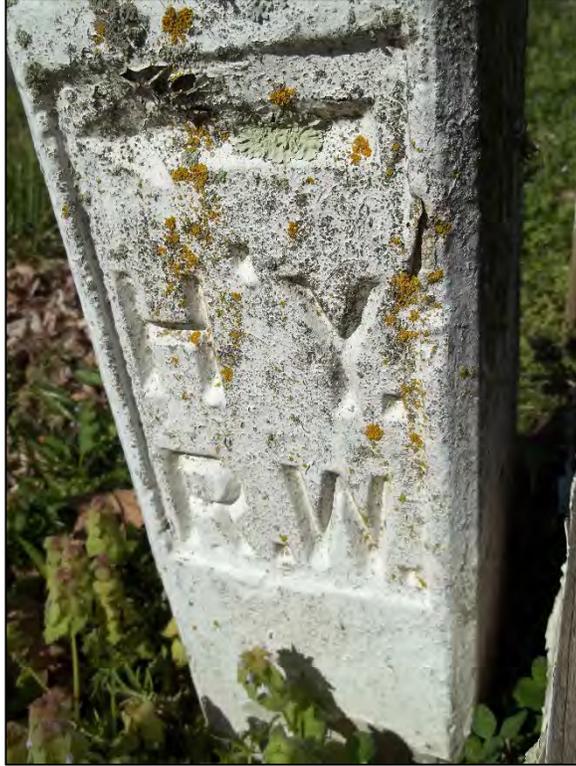
Highway marker in front of the house.

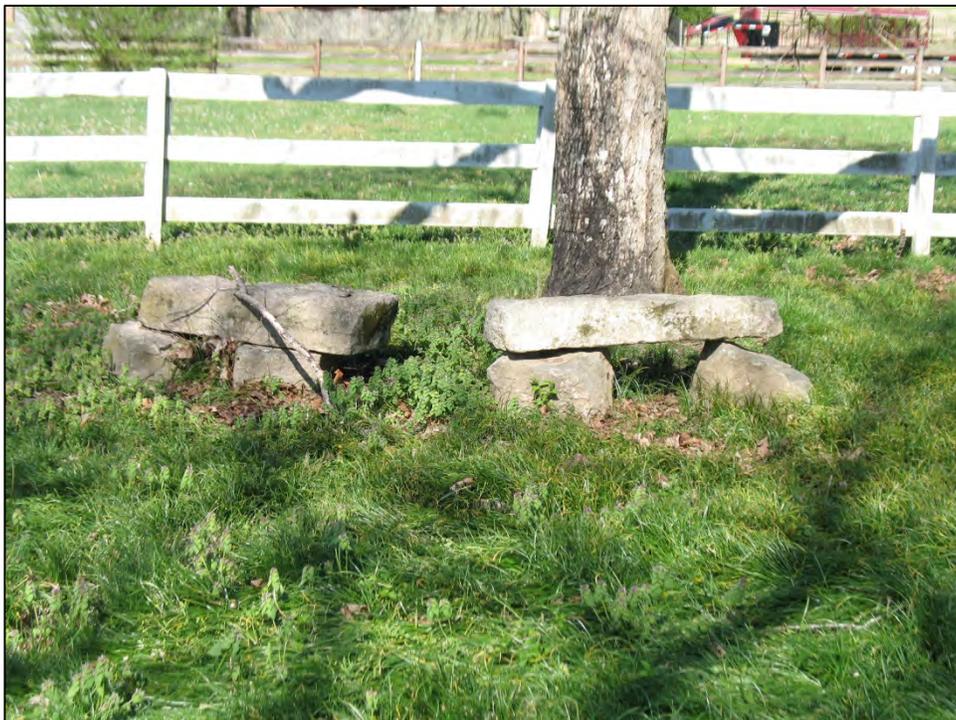
Two stone benches are located in the front of the house, beneath a tree.

Stone benches located at the front of the house.
